BONOMI INDUSTRIES SRL

TECHNICAL DATA SHEET SILICONE BAD EFFECTS ON PAINTING PROCESS

TDS 0025

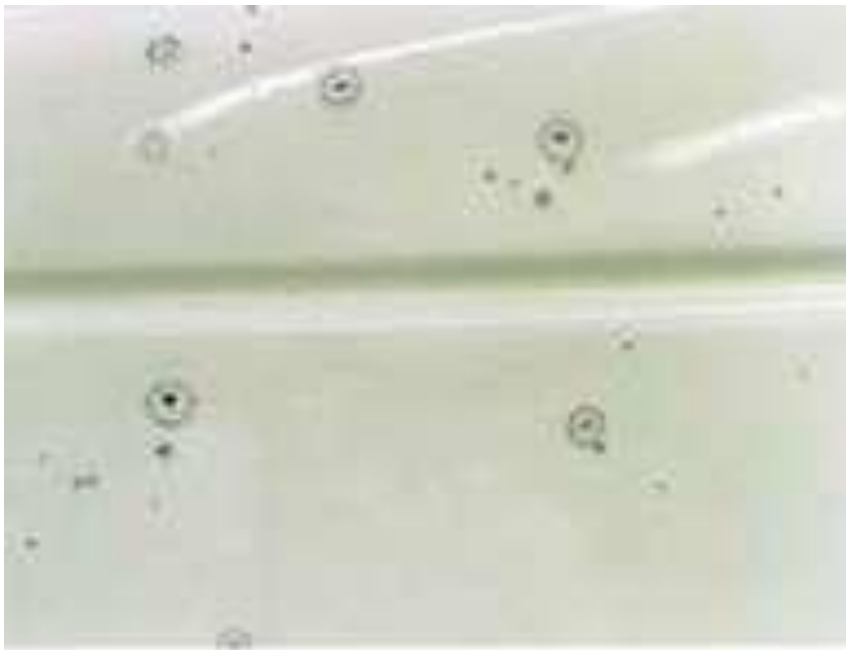
Small, crater-like openings in the finish caused by contamination on the surface being painted

Silicone is among major painting contamination culprits that cause fish eyes, which look like little craters where the paint pull away from the center, which occurs immediately upon spraying. Fish eyes are caused by contamination of the surface to be sprayed, or of the devices used to apply paint.
